Edington (Shapwick and Catcott) Infiltration Reduction Plan Summary

April 2019 – March 2020

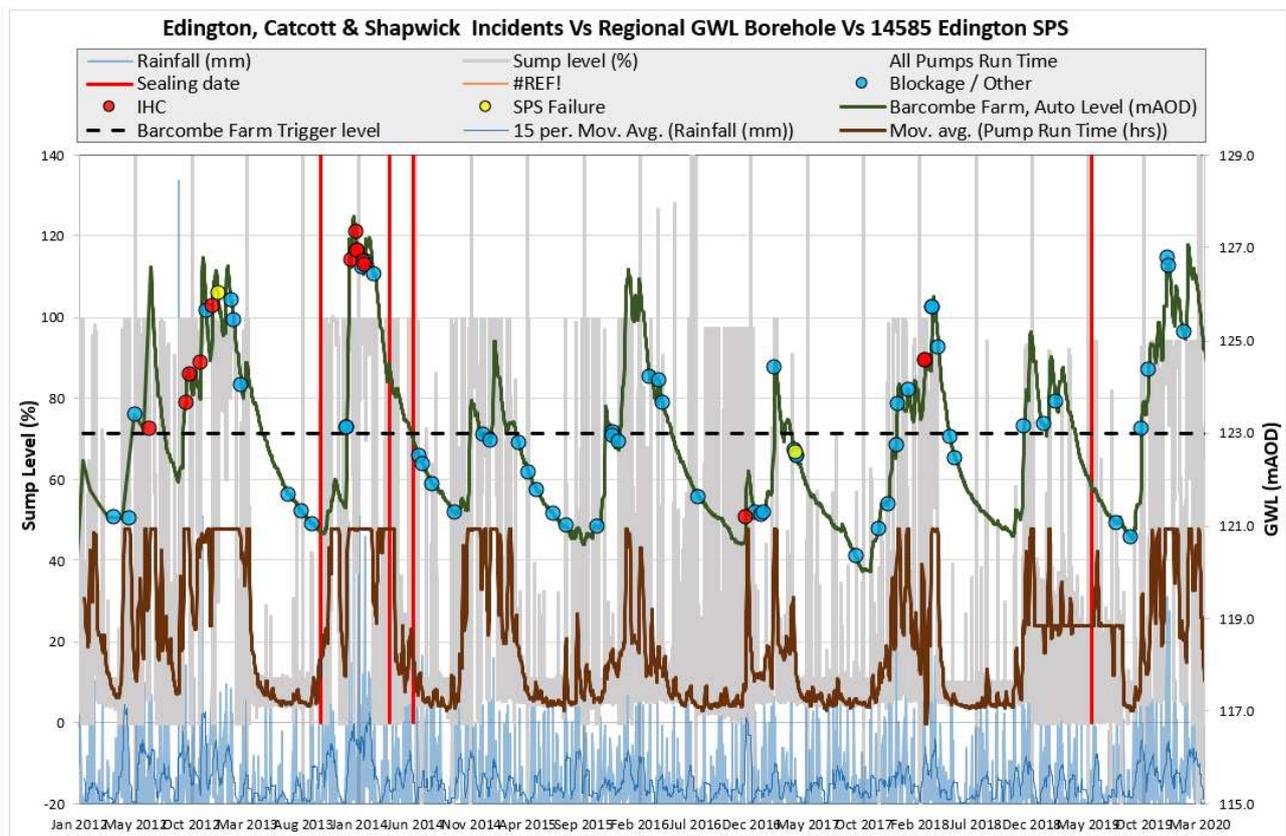
This graph shows incidents against groundwater level (as measured at Barcombe Farm borehole) and the telemetry at Edington Sewage Pumping Station. Although several lengths were rehabilitated in July 2019, infiltration is still evident in the catchment. However, there is a significant decrease in reported incidents in the year, with the last flooding instance due to inadequate hydraulic capacity (IHC) being recorded in March 2018.
